**COMPREHENSIVE SURVEY FOR ASBESTOS CONTAINING
MATERIALS**

**Building 10
Veterans Affairs Medical Center
1970 Roanoke Blvd
Salem, Virginia 24153
Adelaide Project No. VAMC: 10079.00-IN**

**Department of Veterans Affairs
Veterans Affairs Medical Center
1970 Roanoke Blvd
Salem, Virginia 24153**

July 26, 2010

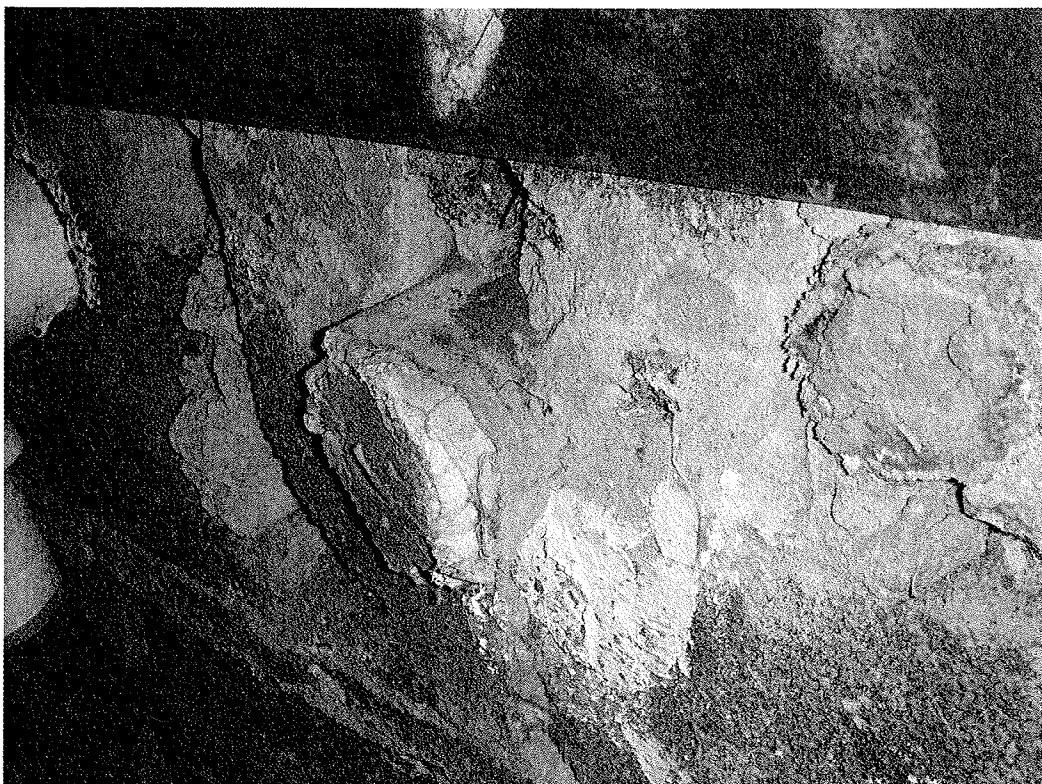
Space #	Homogenous Area	Material Description	Quantity	Condition Response Action
125E	21	Pipe insulation. 6 Exposed ends are cut off at wall penetrations and 3 are partially covered with mortar.	4 LF	Significantly Damaged/Remove/ Required - High Priority
126	21	Pipe Insulation (pipes along back wall are not clean and have ACM residue on them	1 LF	Significantly Damaged/Remove/ Required - High Priority
126A	21	Pipe Insulation (Between CMU walls toward back of the chase)	8 LF	Damaged/Removal/Required
128A	21	Pipe Insulation (above plaster ceiling and visible from 126A)	2 LF	Damaged/Removal/Required
129	21	Multiple Sizes of TSI Pipe Insulation and Pipe Fittings (exposed ends visible in chase)	in chase	Damaged/Enclosure/Required
Chase 209A	21	Pipe fitting insulation residue on two valves (from porr abatement)	2 LF	Significantly Damaged/Remove/ Required - High Priority
211A	4	Vertical Caulk on exterior porches were wooden pillars and brick meet	80 LF	Good/Defer Action/None Required

Chase 125E - Asbestos Pipe Insulation with exposed and mortared ends

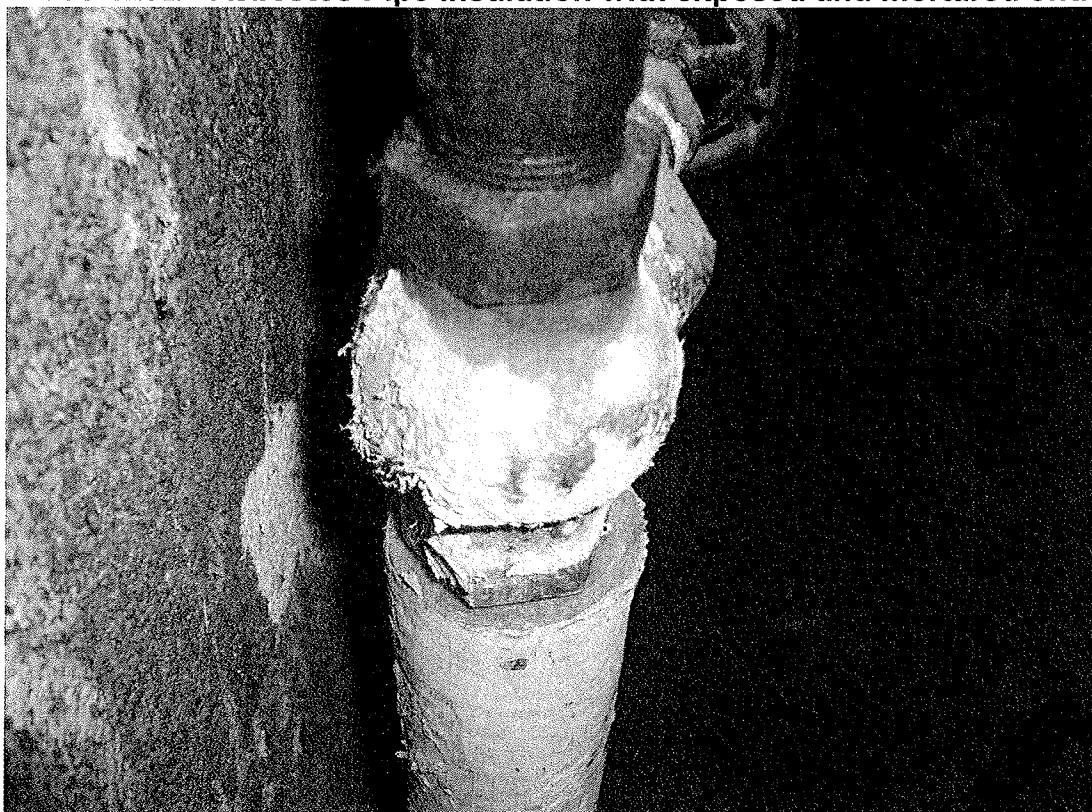
Chase 209A – Asbestos pipe insulation residue on valves from poor abatement

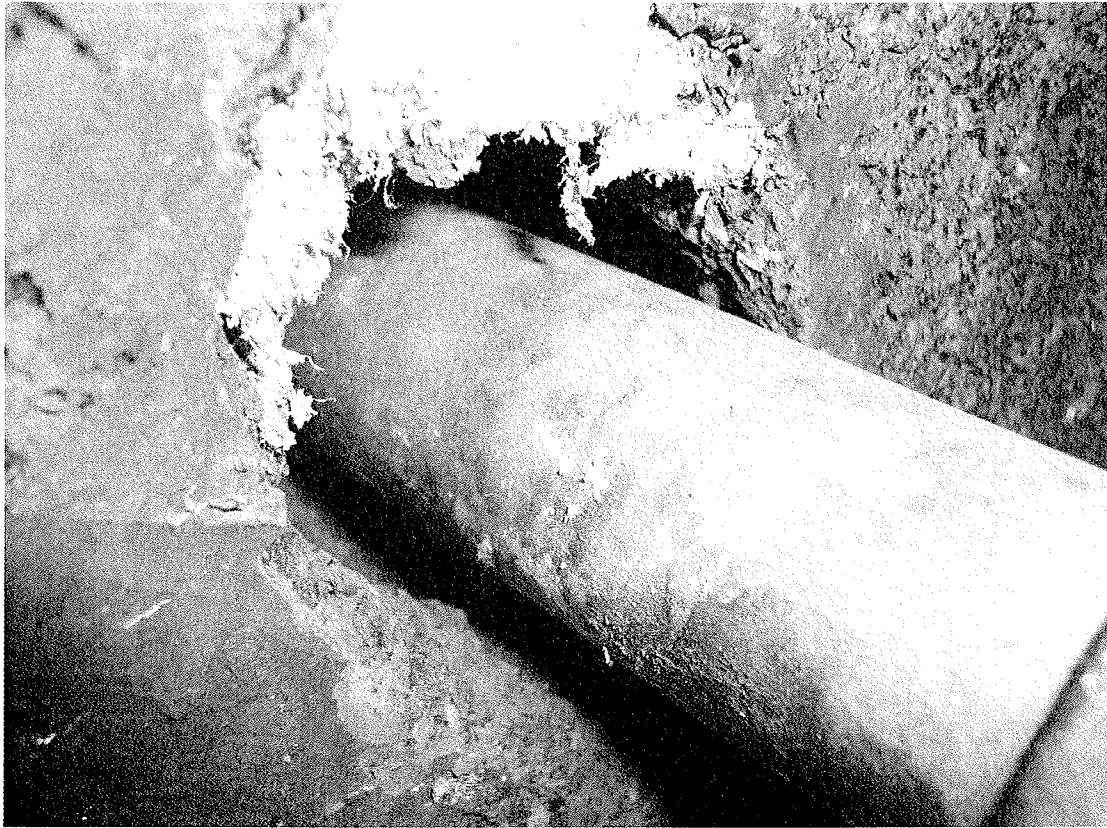
Chase 216A	21	Pipe insulation is left in wall and chase is dirty	1 LF	Significantly Damaged/Remove/ Required - High Priority
224A	4	Vertical Caulk on exterior porches were wooden pillars and brick meet	80 LF	Good/Defer Action/None Required
Chase 225A	21	Pipe Insulation toward ceiling	<1 LF	Significantly Damaged/Remove/ Required - High Priority
227A	21	Pipe Insulation above plaster ceiling (visible from 227)	10 LF	Good/Defer Action/None Required
Exterior	16	Exterior Door Caulk	180 LF	Good/Defer Action/None Required
Exterior	17	Old Window Caulk underneath new caulking	5000 LF	Good/Defer Action/None Required

Chase 216A – Pipe insulation debris left in wall penetration

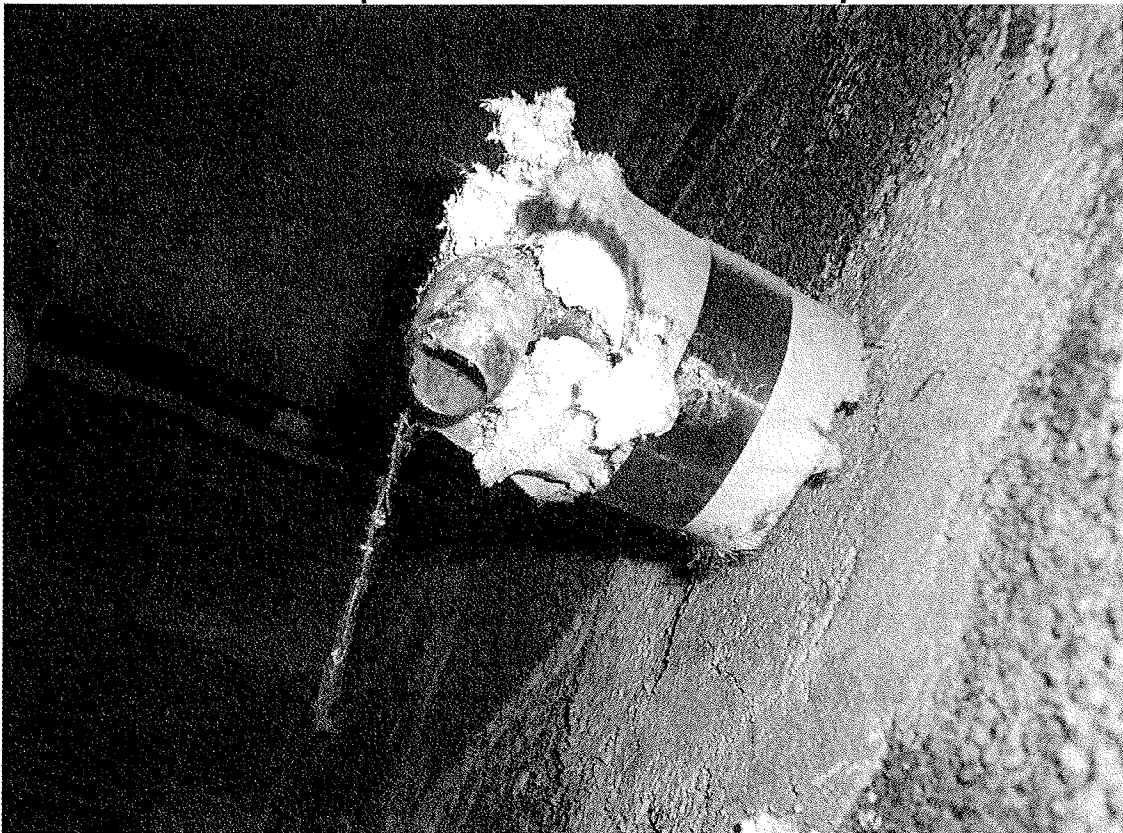
Chase 225A – Significantly damaged piece of asbestos pipe insulation (rest of chase has been abated)

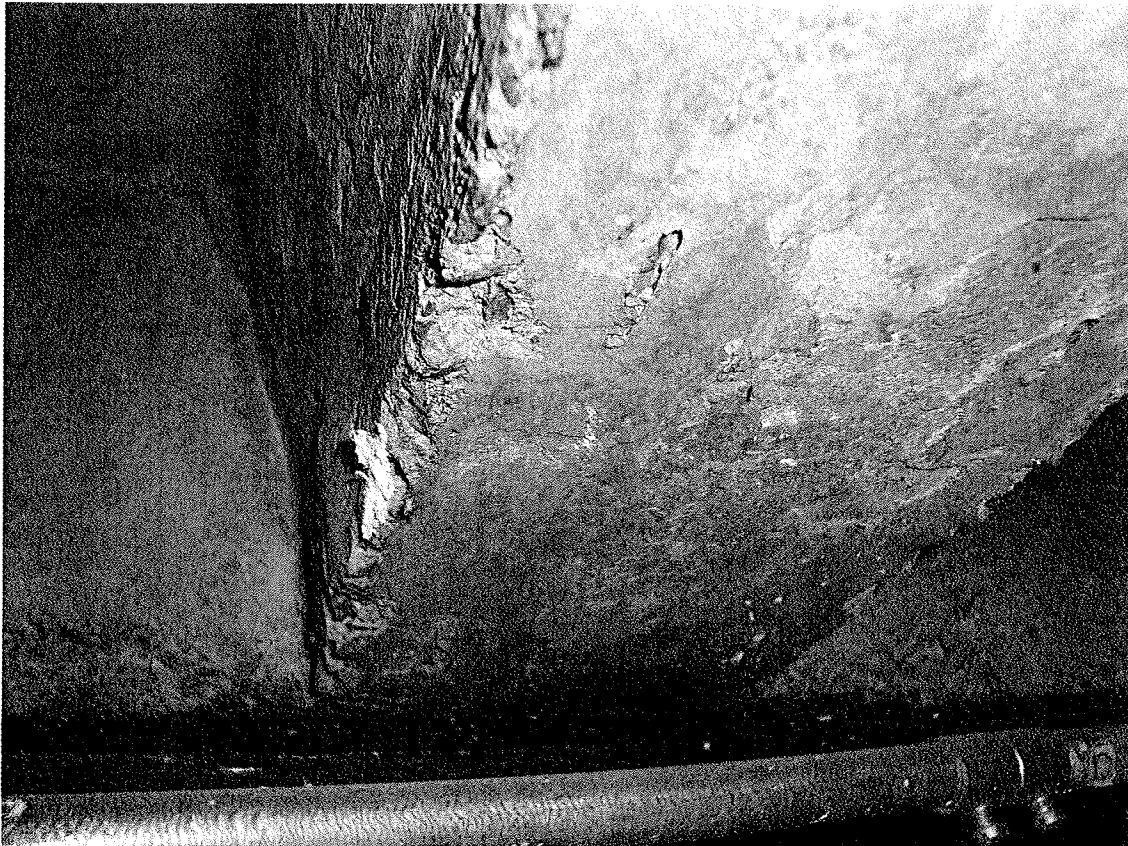
Room 122 – Pipe insulation residue/debris on concrete ceiling and electrical lines

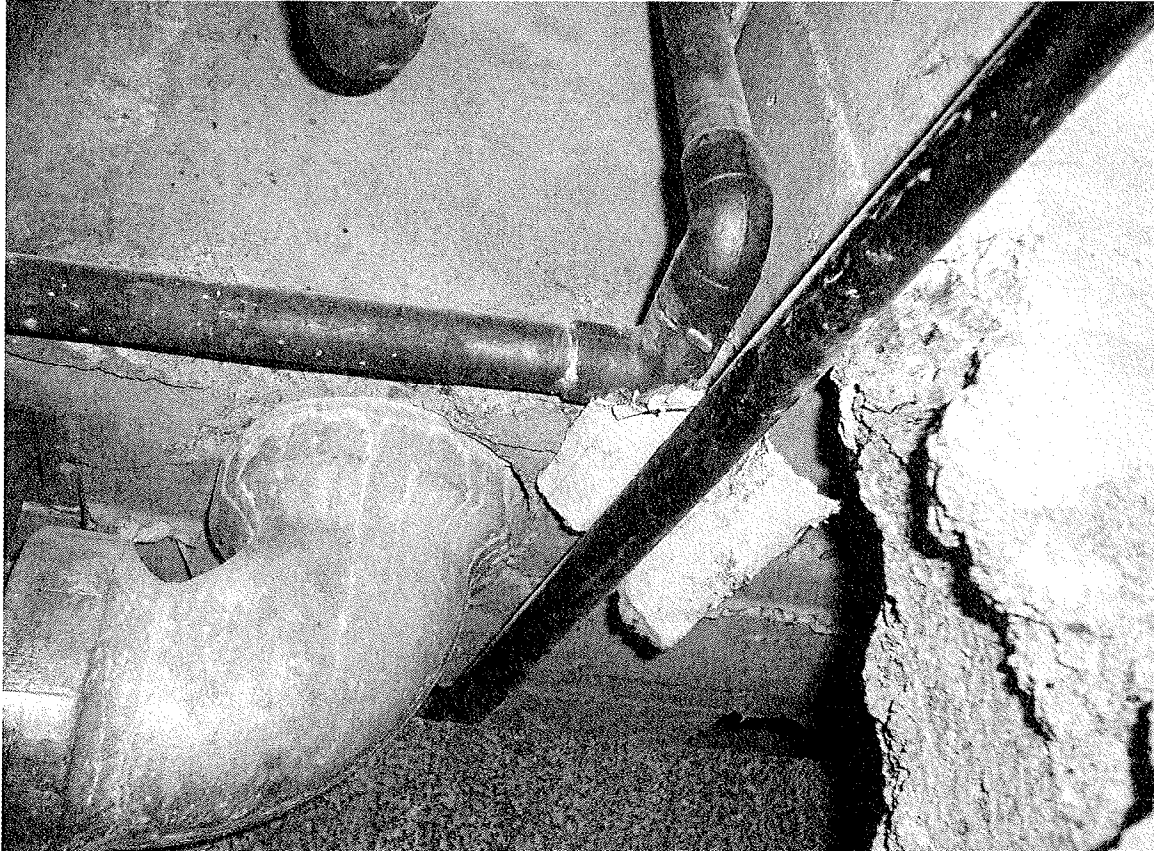
Room 123 – Piece of asbestos pipe insulation missed during abatement

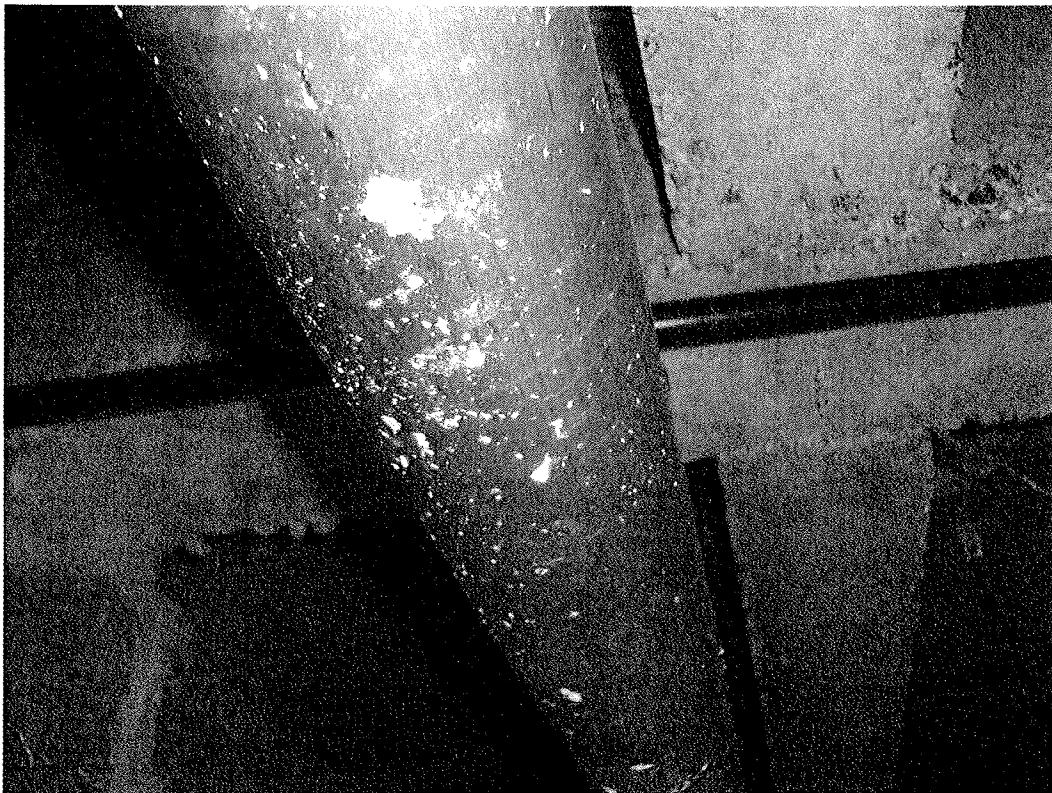
Room 123 – Asbestos Pipe Insulation residue/debris on abated pipe

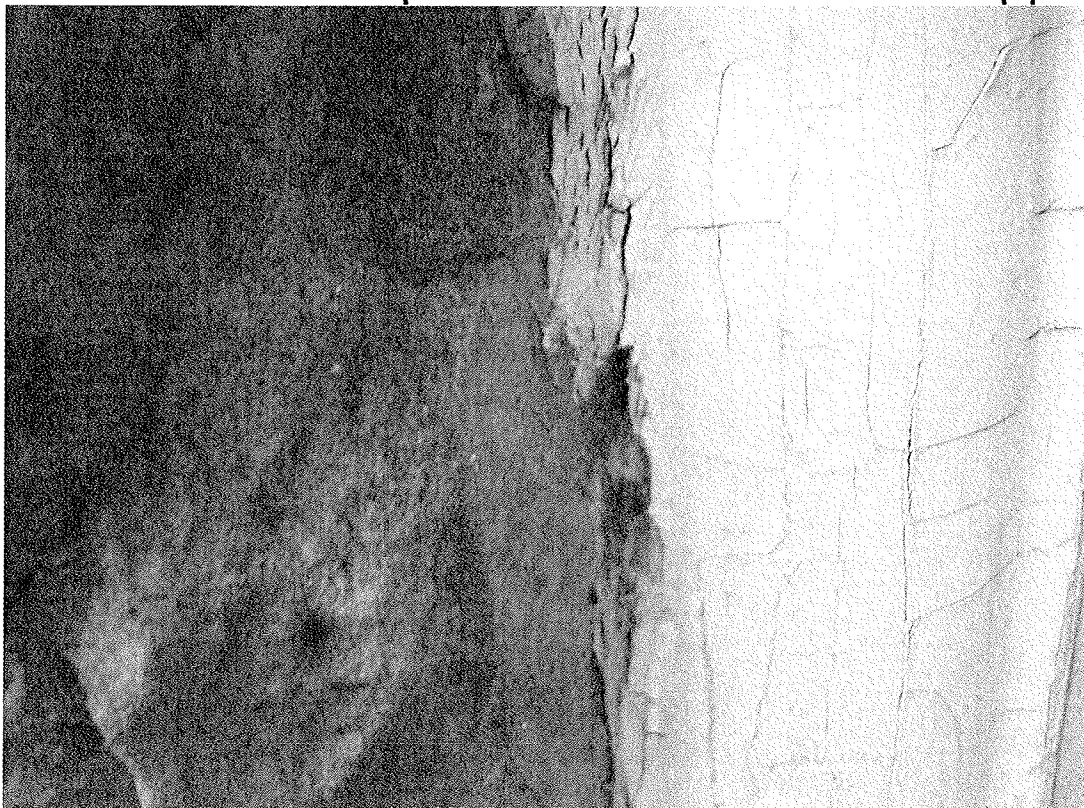
Exterior Door Caulk

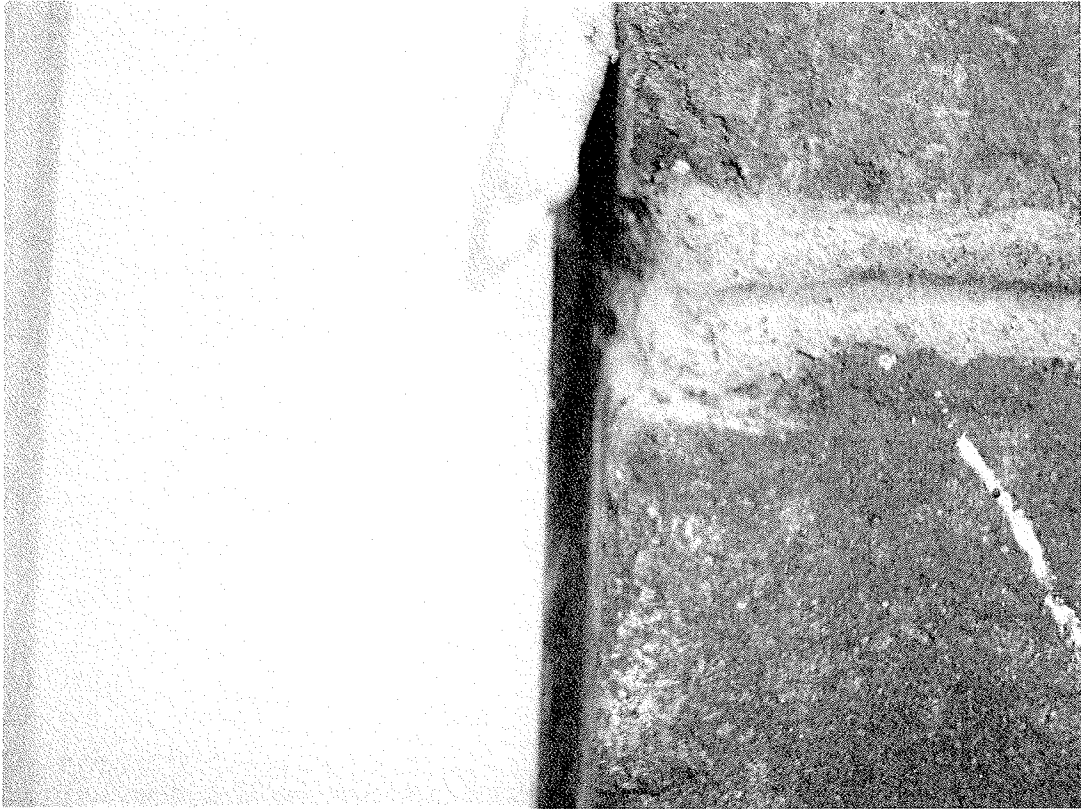
Old window caulking underneath new caulking

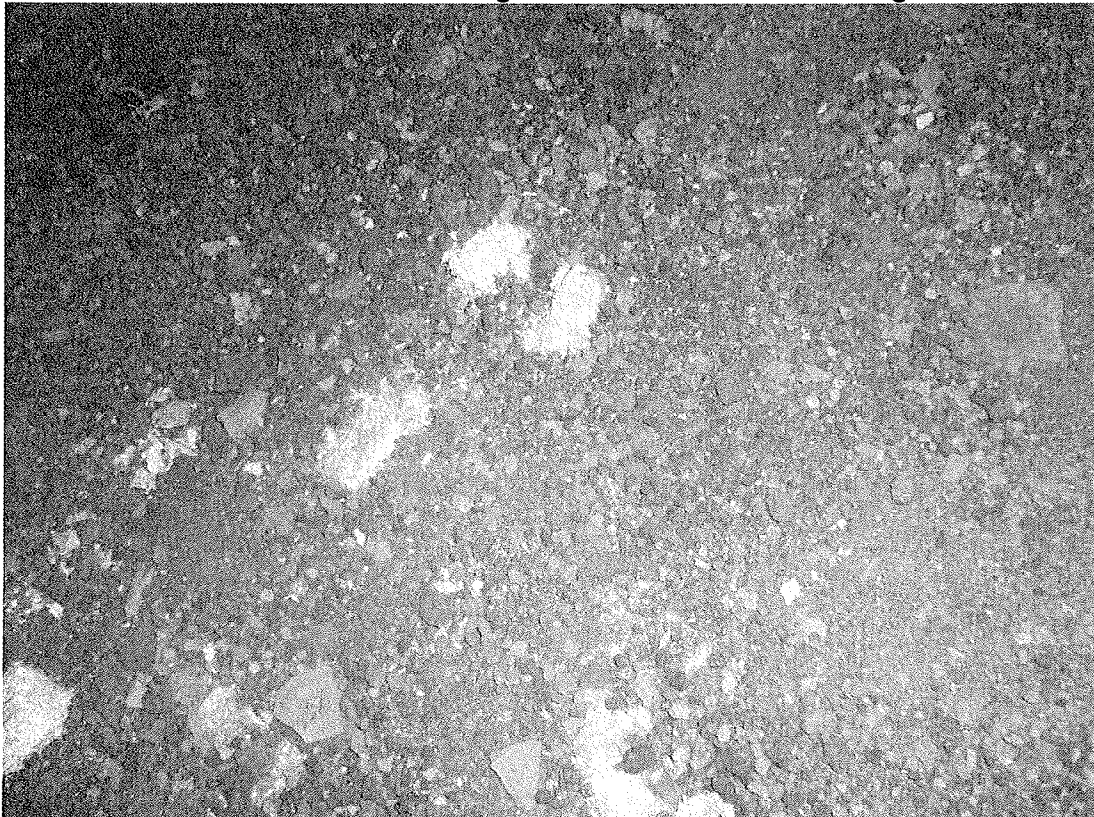
The entire crawlspace is contaminated and needs to be cleaned before workers and visitors are allowed to enter. Refer to Appendix A for a list of rooms which have materials that require immediate high-priority attention.

Asbestos pipe insulation debris in dirt of crawlspace – 20% Amosite

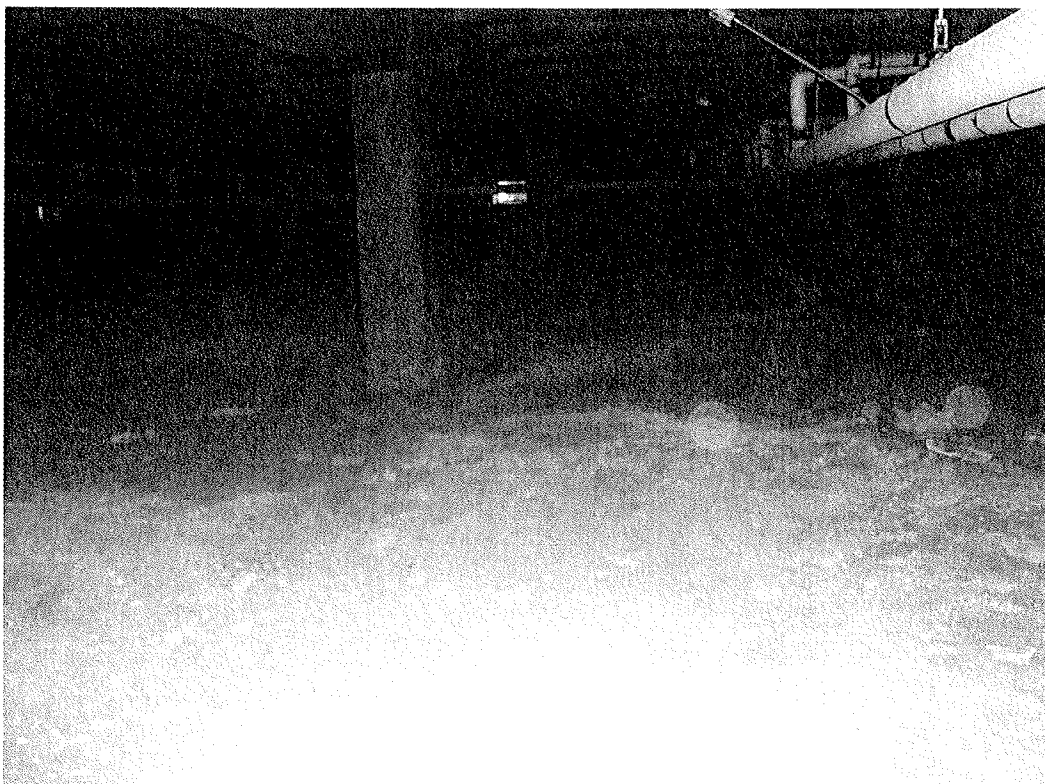
Crawlspace view with Asbestos pipe insulation and contaminated dirt floor

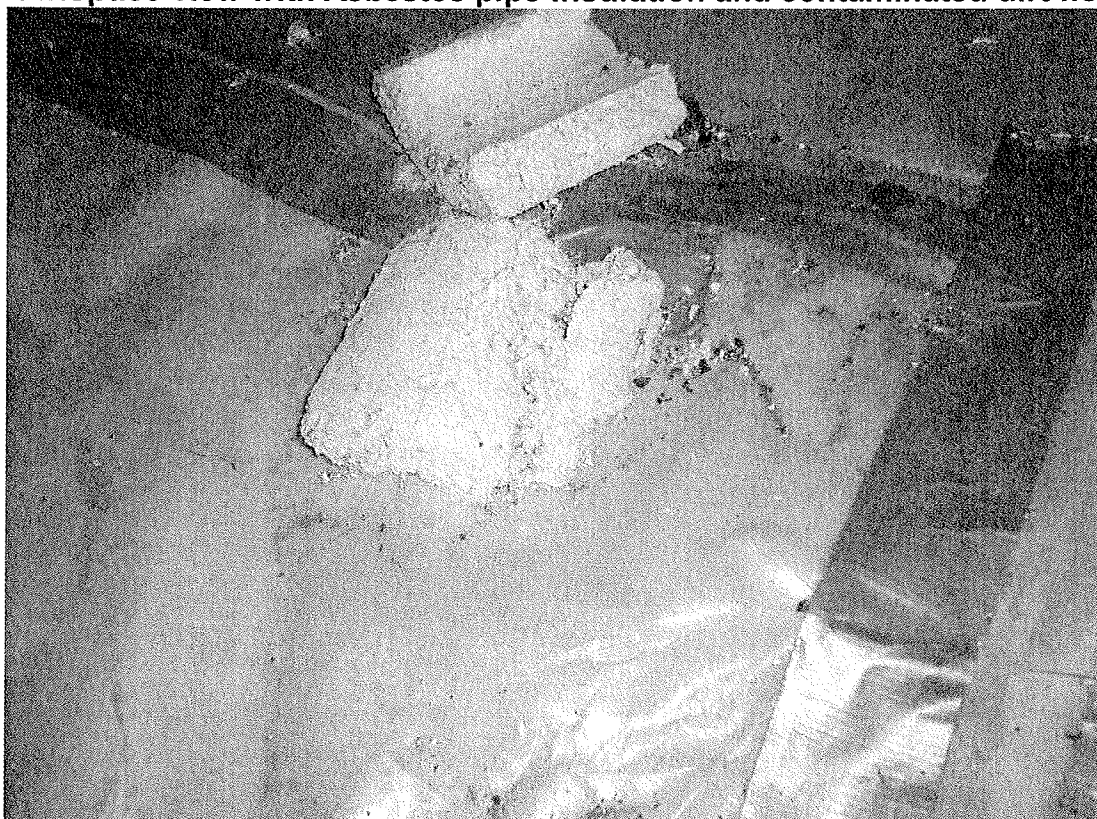
Crawlspace – asbestos pipe insulation debris on poly covering parts of the dirt floor – 35% asbestos

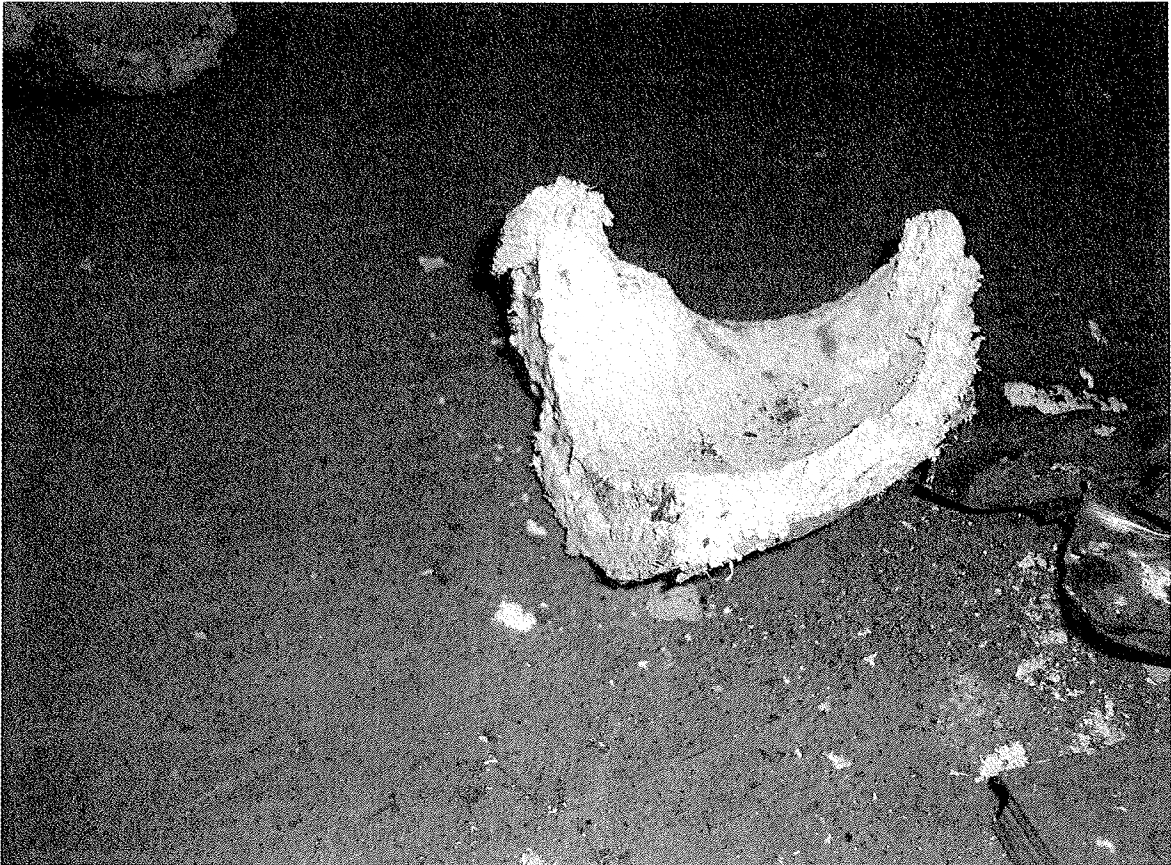
Crawlspace – asbestos pipe insulation contaminating the space
